Filling your *knowledge* on the Mabalingwe *dams*

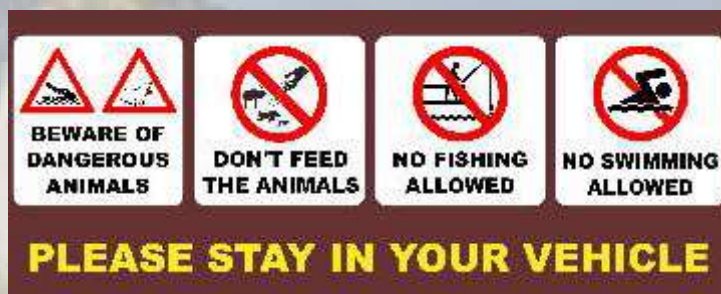
All our dam signage has been replaced in accordance with dam safety regulations.
